10010
M/037/0026
TASK 3244
CCL TOWN
Denison Mines (USA) Corp.
1050 17th Street, Suite 950
Denver, CO 80265
USA

Re: Closure Plan for 1280 Vent La Sal/Snowball Permit Number M/037/026

Denison Mines (USA) Corp.			
Project: Beaver Shaft Mine			
REVISIONS	County: San Juan	State: Utah	
Date	By	Location:	
		1280 Ventilation Shaft Ground Failure	
		June 29, 2009	
Scale: No Scale	Date: June 30, 2009		
Author: S. McCourt	Drawn By: S. McCourt

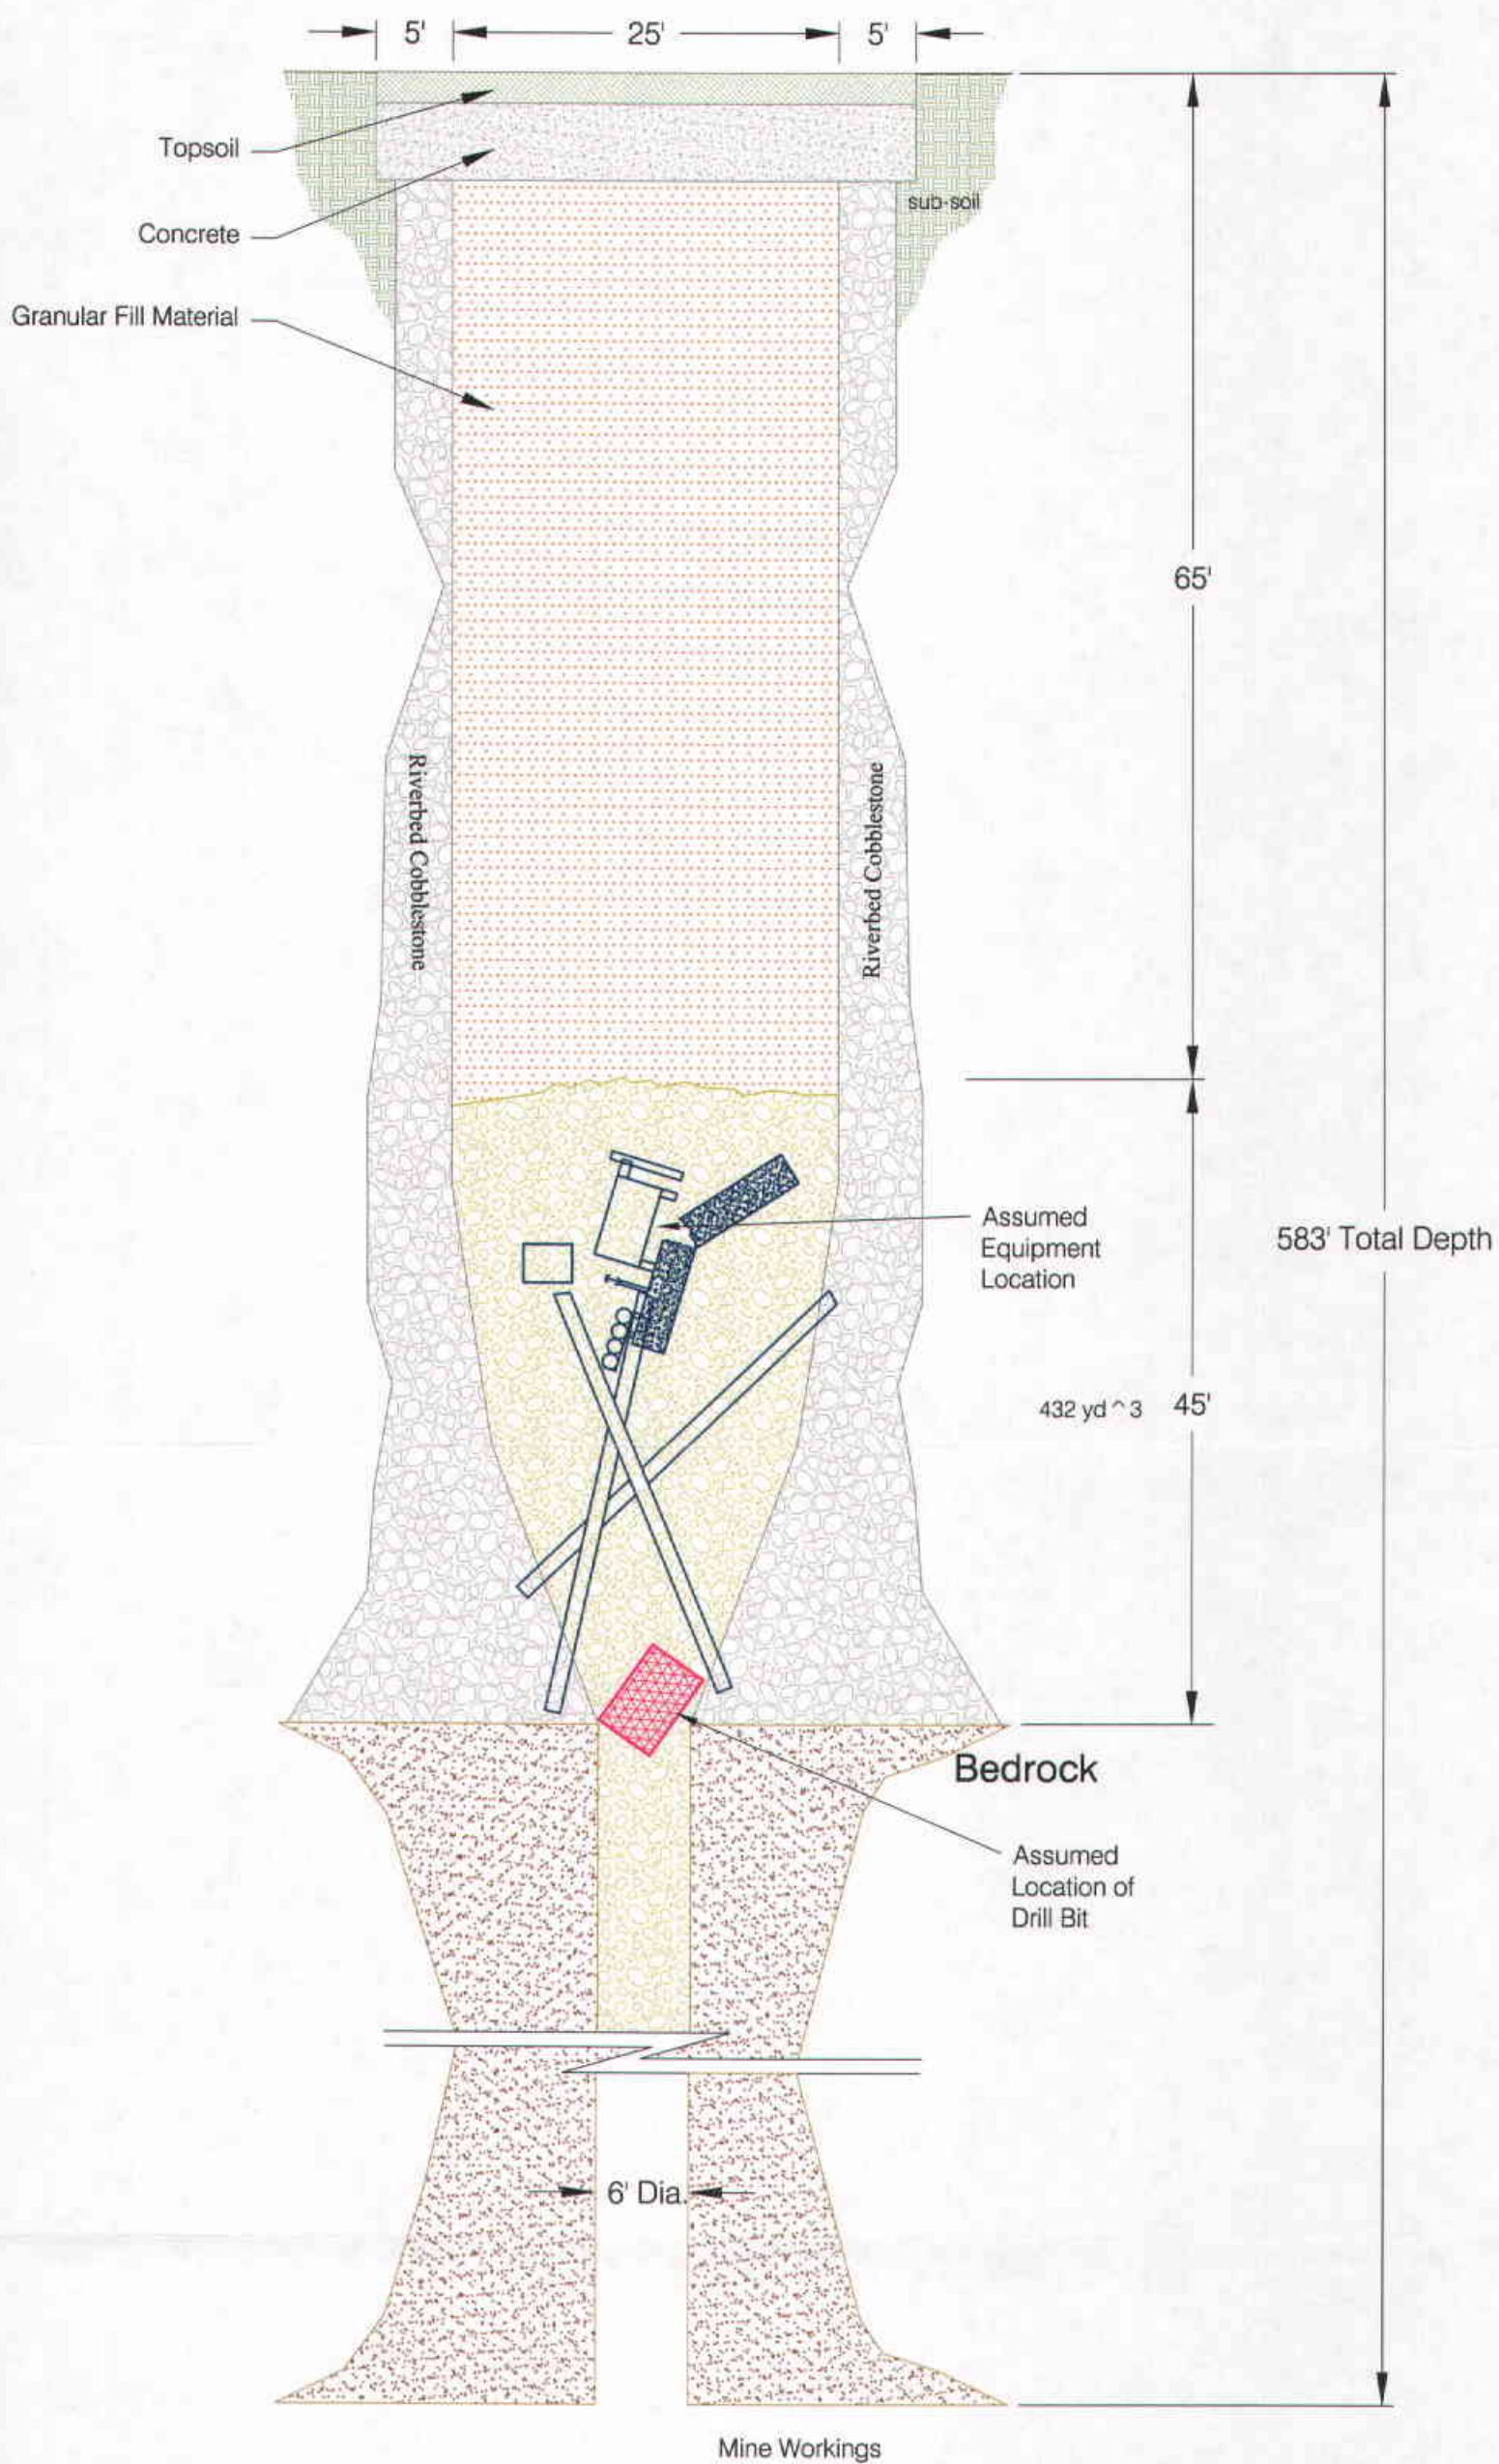
The opening on the ground surface is approximately 28 feet by 18 feet, and the surface soil type is sand and gravel mix. The cement pad to which the drill was anchored was 15 feet by 15 feet and 26 inches thick. The drill is totally covered with material and the material is approximately 65 feet below the surface. The area has been barricaded and secured.

Denison will close the drill hole by backfilling the hole with granular fill material, providing a 3 to 5 foot thick concrete pad extending approximately 5 feet outside of the existing hole diameter (total diameter of 30 feet over the approximate 25 foot hole) and then covering the area with 2 feet of topsoil. Denison will seed the area with the UDOGM approved seed mix. Gravel fill material will come from either the County owned gravel pit, located less than 5 miles away from the site. A schematic of the closure process is attached.
